**Report on the preliminary  
fact finding mission  
following the accident at the  
nuclear fuel processing  
facility in Tokaimura, Japan**

INTERNATIONAL ATOMIC ENERGY AGENCY, VIENNA, 1999

REPORT ON THE PRELIMINARY  
FACT FINDING MISSION  
FOLLOWING THE ACCIDENT AT THE  
NUCLEAR FUEL PROCESSING FACILITY  
IN TOKAIMURA, JAPAN

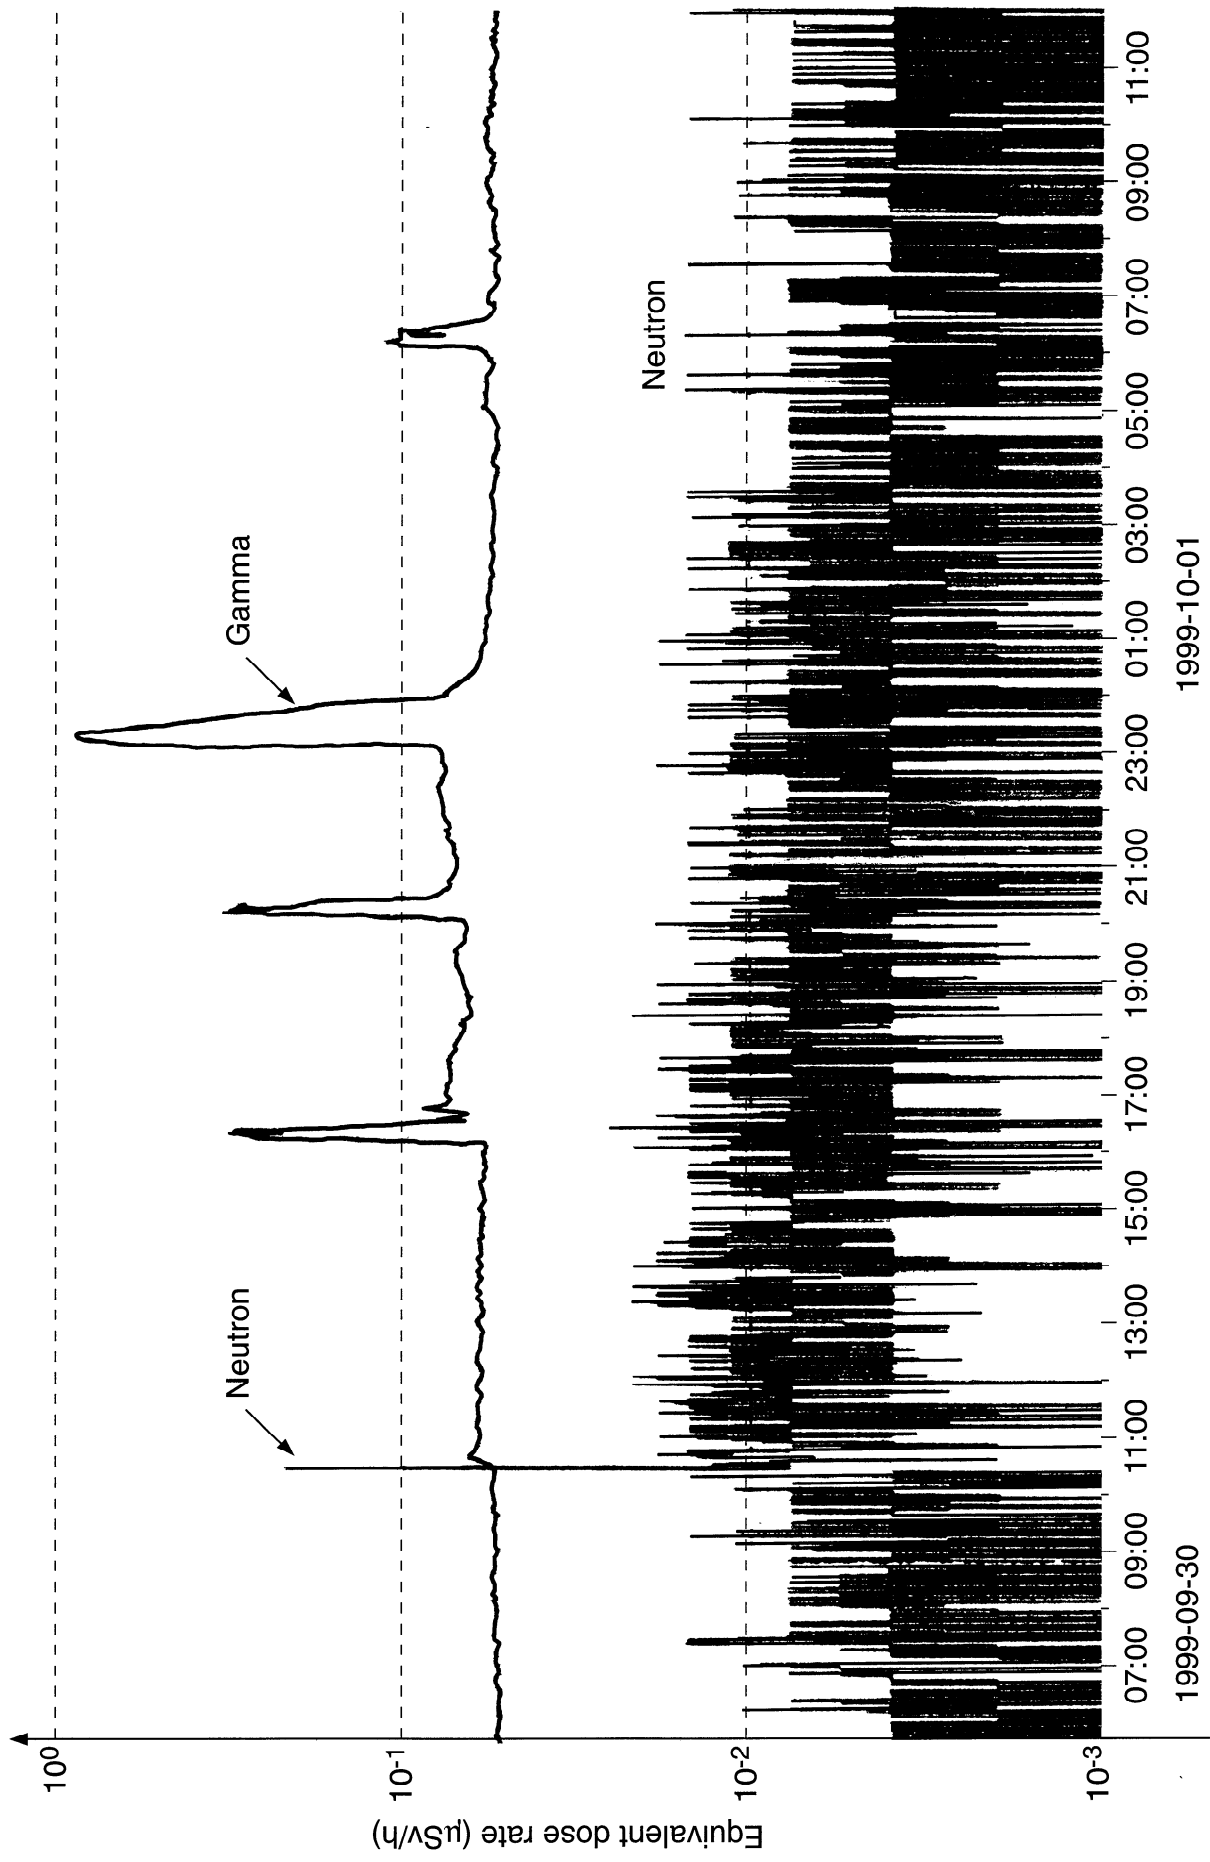
Intermittent increases in gamma dose rates were also observed at MP-1 and MP-2 monitoring posts at the JAERI Naka site after the accident and continued until 00:00 on 1 October (see Fig. 18). The JAERI experts considered that the increase in the gamma dose rate immediately after the accident began was due to direct gamma radiation associated with the criticality reaction, and the subsequent peaks were due to gamma radiation from the plume borne by the wind, which may have contained radioactive noble gases and iodine released into the atmosphere from the conversion building during the criticality event [23].

Fig. 18. Gamma and neutron equivalent dose rates at JAERI Tokai Site monitoring post MP-1 (1.7 km from the conversion building).
